In-Plane And Out-Of-Plane Performance Of The Universal Building Products “Bullhorn” Connector

**IN-PLANE AND OUT-OF-PLANE PERFORMANCE
OF THE
UNIVERSAL BUILDING PRODUCTS
EDGE CONNECTOR SYSTEM**

July 2009

ATLSS REPORT NO. 09-02

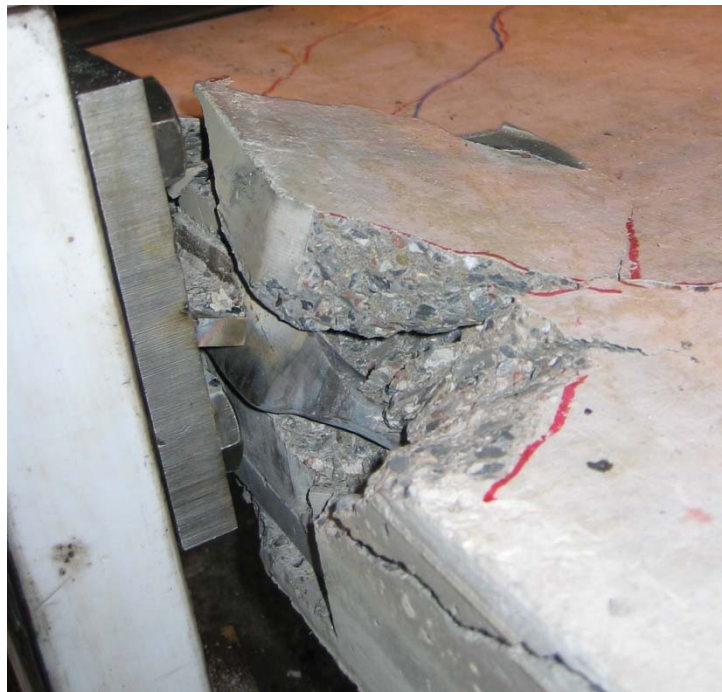
Figure 46: Final condition of test E2

Table 20: Key Test Observations (Out-of-plane shear) E2		
Event #	Shear Δ Step [in.]	Event Description
1	0.09	First two diagonal cracks formed on the panel
2	0.32	One more diagonal crack formed on right side of the panel
3	0.97	More small cracks formed around the connector, concrete started spalling
4	1.58	Concrete continued spalling
5	2.37	Connector sheared out of the panel

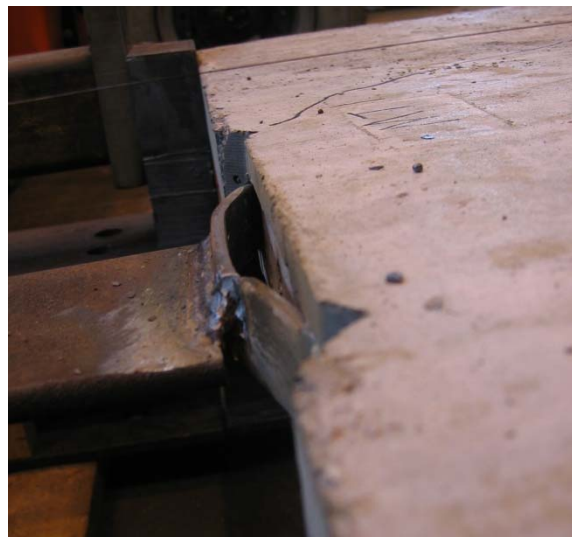
Figure 49: Final condition of test A3

The performance of the Universal connection subject to monotonic, in-plane tension is presented in this section. The connector was subjected to in plane tension displacement with the shear force unrestrained. Connector response was characterized by bending of the faceplate with application of tension. No damage was observed on the concrete surrounding the connection. The weld began to fracture on the tip of the slug at a tension displacement of 0.75 in. Loss in capacity occurred due to failure of the faceplate. The observed key events and the corresponding displacement level are presented in Table 22. The photos of the damage states are presented in Figure 48. The initial final conditions of the specimen are presented in Figure 49. The global force deformation response and backbone curve are presented in Table 23 and Figure 50.

Table 22: Key Test Observations (In-plane tension) A3		
Event #	Tension Δ Step [in.]	Event Description
1	0.38	Faceplate bent and fracture of weld initialed at the tip
2	0.42	Faceplate fractured vertically

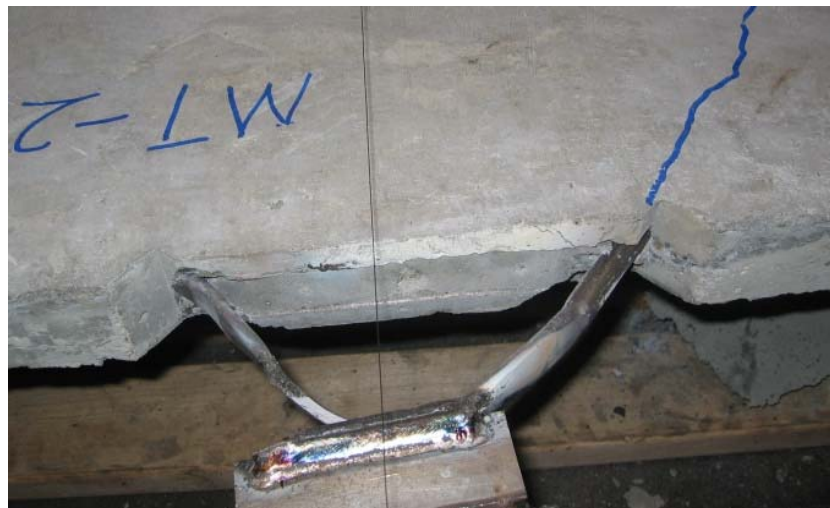
Figure 52: Final condition of test B3

The performance of the Universal connection subject to monotonic, in-plane tension is presented in this section. The connector was subjected to in plane tension displacement with the shear force unrestrained. Connector response was characterized by bending of the faceplate with application of tension. The weld began to fracture on the tip of the slug at a tension displacement of 1.78 in. The test was conducted until the load cell was out of stroke. The observed key events and the corresponding displacement level are presented in Table 24. The photos of the damage states are presented in Figure 51. The initial final conditions of the specimen are presented in Figure 52. The global force deformation response and backbone curve are presented in Table 24 and Figure 53.

Table 24: Key Test Observations (In-plane tension) B3		
Event #	Tension Δ Step [in.]	Event Description
1	0.28	Faceplate bending
2	0.70	One minor diagonal crack formed above the compression leg of connector
3	1.78	Faceplate was continually bent and fracture of weld initialed at the left tip
3	2.23	Load cell was out of stroke

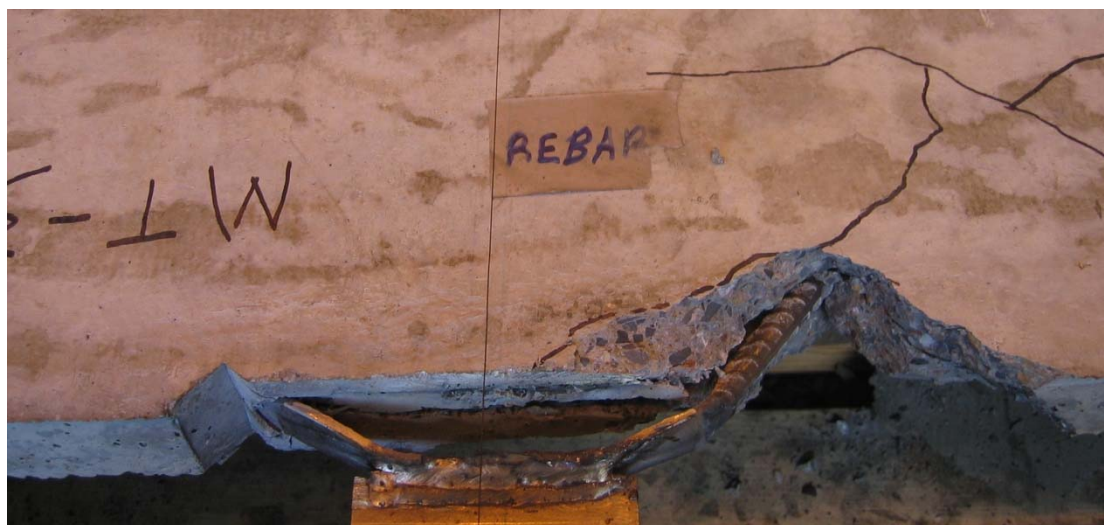
Figure 55: Final condition of test C1

The performance of the Universal connection subject to monotonic, in-plane tension is presented in this section. The connector was subjected to in plane tension displacement with the shear force unrestrained. Connector response was characterized by bending of the faceplate and the concrete cracks around the connector leg with application of tension. Failure occurred due to the breakout of concrete surrounding the connector legs. The observed key events and the corresponding displacement level are presented in Table 26. The photos of the damage states are presented in Figure 54. The initial final conditions of the specimen are presented in Figure 55. The global force deformation response and backbone curve are presented in Table 27 and Figure 56.

Table 26: Key Test Observations (In-plane tension) C1		
Event #	Tension Δ Step [in.]	Event Description
1	0.18	Faceplate bending
2	0.35	Cracks formed above the compression leg of connector; Faceplate was continually bent
3	0.72	Faceplate was continually bent; Concrete panel spalled
3	0.75	Concrete breakout around the right connector leg

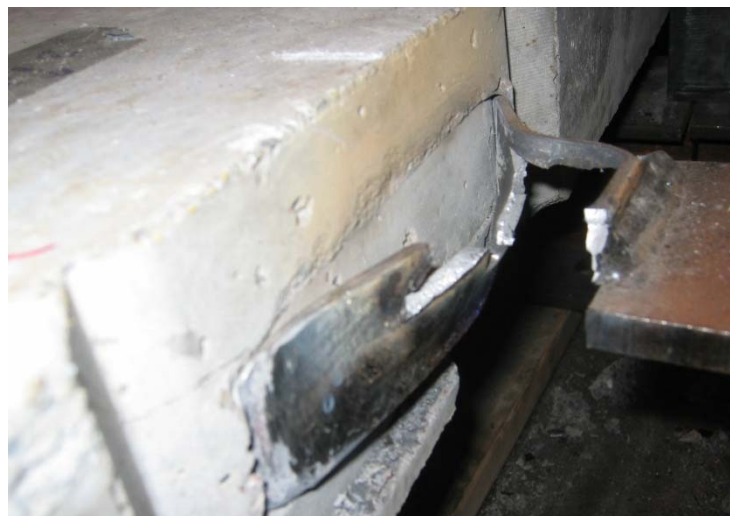
Figure 58: Final condition of test D3

Table 28: Key Test Observations (In-plane tension) D3		
Event #	Tension Δ Step [in.]	Event Description
1	0.46	Faceplate bending; weld began to fracture at the right tip
2	0.64	Faceplate yield and began to fracture, weld continually fractured
3	0.72	Faceplate continually fractured horizontally ;
4	0.82	Faceplate continually fractured horizontally ;
5	1.78	End of test

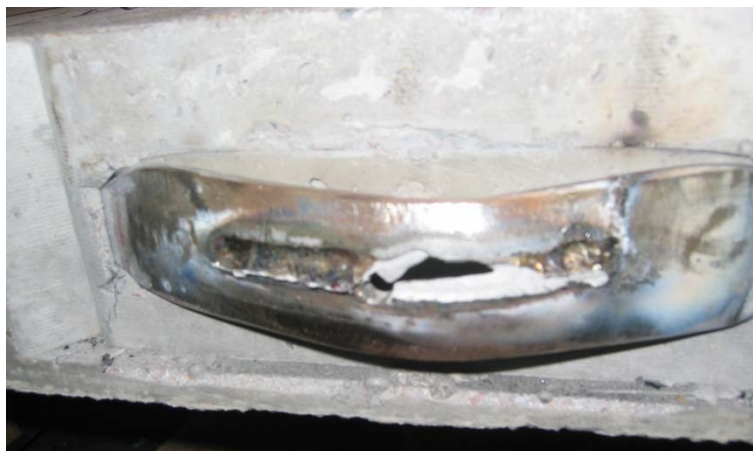
Figure 61: Final condition of test E3

Table 30: Key Test Observations (In-plane tension) E3		
Event #	Tension Δ Step [in.]	Event Description
1	0.61	Faceplate bending; weld began to fracture at the left tip
2	0.90	Weld began to fracture at the right tip
3	1.15	Faceplate yield and began to fracture, weld continually fractured
4	2.41	Plate completely fractured

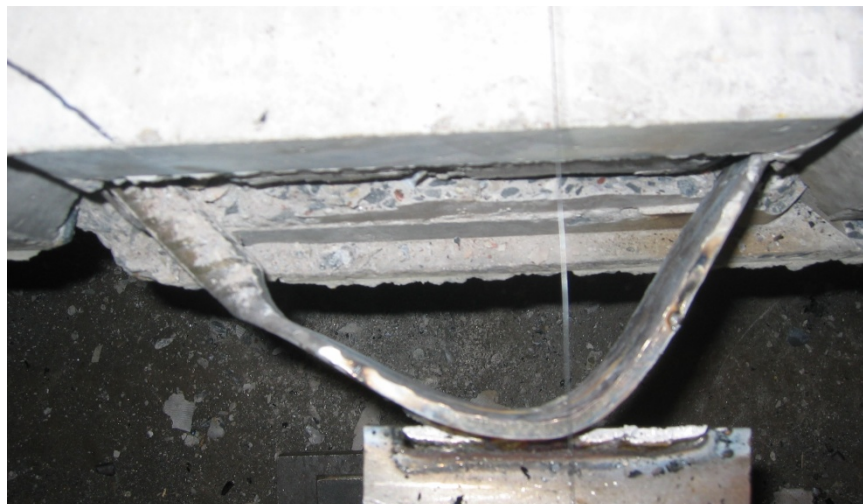
Figure 64: Final condition of test F1

Table 32: Key Test Observations (In-plane tension) F1		
Event #	Tension Δ Step [in.]	Event Description
1	0.47	Faceplate bending; weld began to fracture at the both tips; cracks formed on the panel above the tension leg of the connector.
2	0.61	Weld continually fractured, cracks extended
3	0.67	Weld continually fractured
4	1.55	Weld severely fractured; Tension leg was pulled out of the surrounding concrete
5	2.24	End of the test

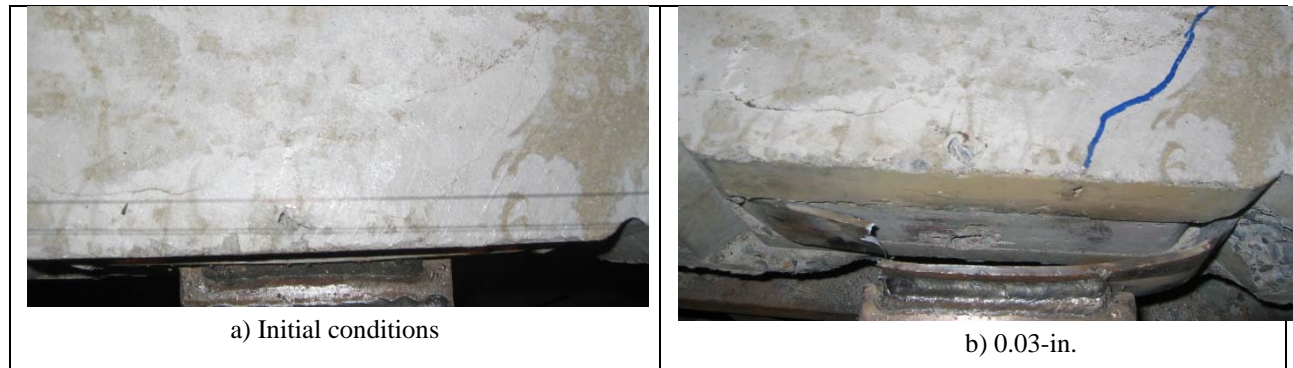
Figure 66: Damage state at various In-plane shear deformations D5

The performance of the Universal connection subject to monotonic in-plane shear is presented in this section. The panel was subjected to shear displacement with the tension force unrestrained. Connector damage progression consisted of faceplate bending followed by faceplate fracture at the tip of weld between slug and faceplate. The ultimate loss in capacity occurred due to abrupt faceplate failure. The observed key events and the corresponding displacement level are presented in Table 34. The photos of the damage states are presented in Figure 66. The final condition of the specimen is presented in Figure 67. The global force deformation response and backbone curve are presented in Table 35 and Figure 68.

Table 34: Key Test Observations (In-plane shear) D5		
Event #	Shear Δ Step [in.]	Event Description
1	0.08	Plate bending
2	0.36	Faceplate fractured abruptly

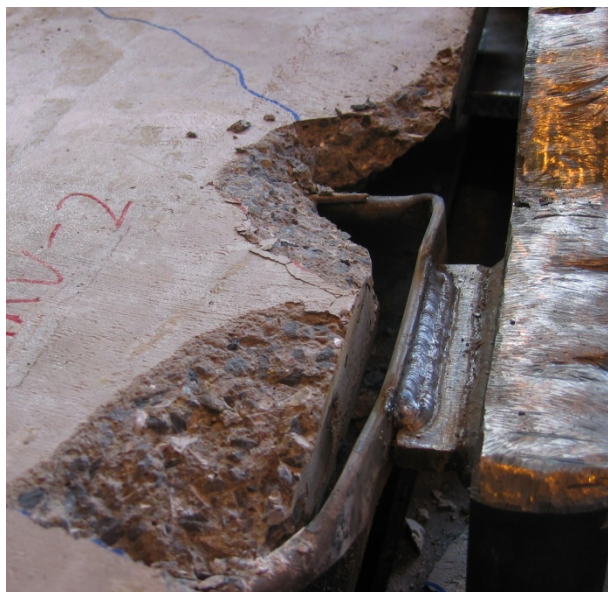
Figure 70: Final condition of test A5

Table 36: Key Test Observations (In-plane shear) A5		
Event #	Shear Δ Step [in.]	Event Description
1	0.14	One minor crack formed on the right side of the panel
2	0.27	Crack progressed and small gap formed b/w panel and faceplate
3	0.75	Concrete Spalling above the compression leg; bending of connector legs
4	1.18	Concrete Spalling above both legs
3	1.49	Concrete sever Spalling above both legs; End of test

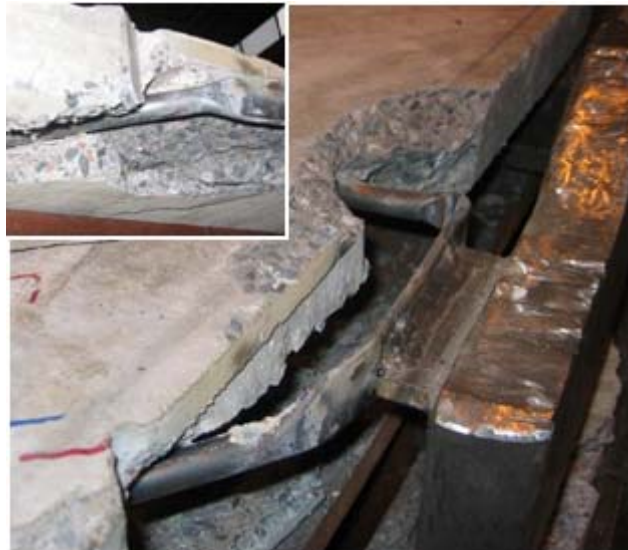
Figure 73: Final condition of test A4

Table 38: Key Test Observations (In-plane shear) A4		
Event #	Shear Δ Step [in.]	Event Description
1	0.27	One minor crack formed on the right side of the panel
2	0.43	Small gap formed b/w panel and faceplate; Concrete Spalling above the compression leg
3	0.90	Bending of connector legs and faceplate; Concrete continually spalled
4	1.01	Concrete began to spall below the tension anchorage leg
5	1.19	Concrete sever spalling above both legs
6	2.34	End of test

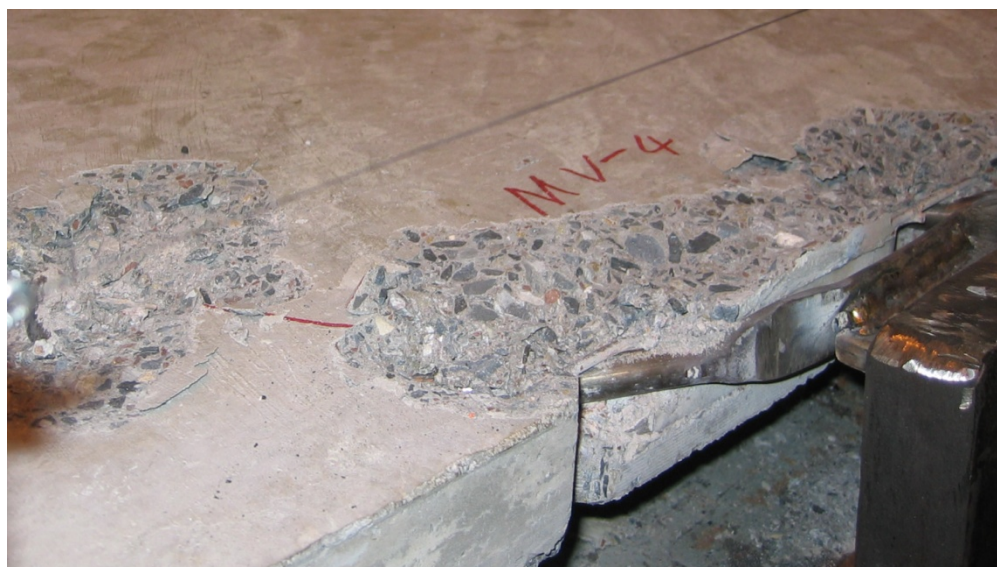
Figure 76: Final condition of test B5

Table 40: Key Test Observations (In-plane shear) B5		
Event #	Shear Δ Step [in.]	Event Description
1	0.33	One minor crack formed on left side of the panel; Faceplate bending; Concrete spalling above the compression leg
2	0.45	Bending of connector legs and faceplate; Concrete Spalling above the tension leg
3	1.32	Concrete continually spalled
6	2.28	End of test

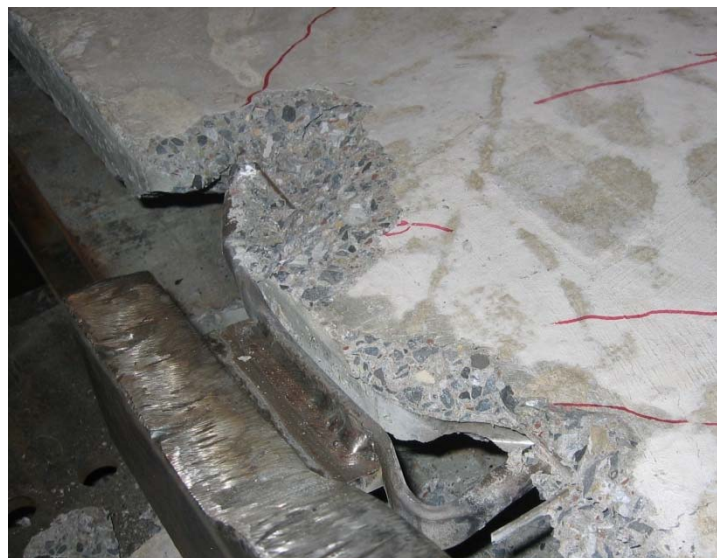
Figure 82: Final condition of test B4

Table 44: Key Test Observations (In-plane shear) B4		
Event #	Shear Δ Step [in.]	Event Description
1	0.44	Faceplate bending; Concrete spalling above the compression leg
2	1.04	Bending of connector legs and faceplate; Crack formed above the tension leg; Concrete began to spall below the tension leg
3	1.55	Concrete continually spalled; Separation of the left anchorage leg from the surrounding concrete
6	1.80	End of test

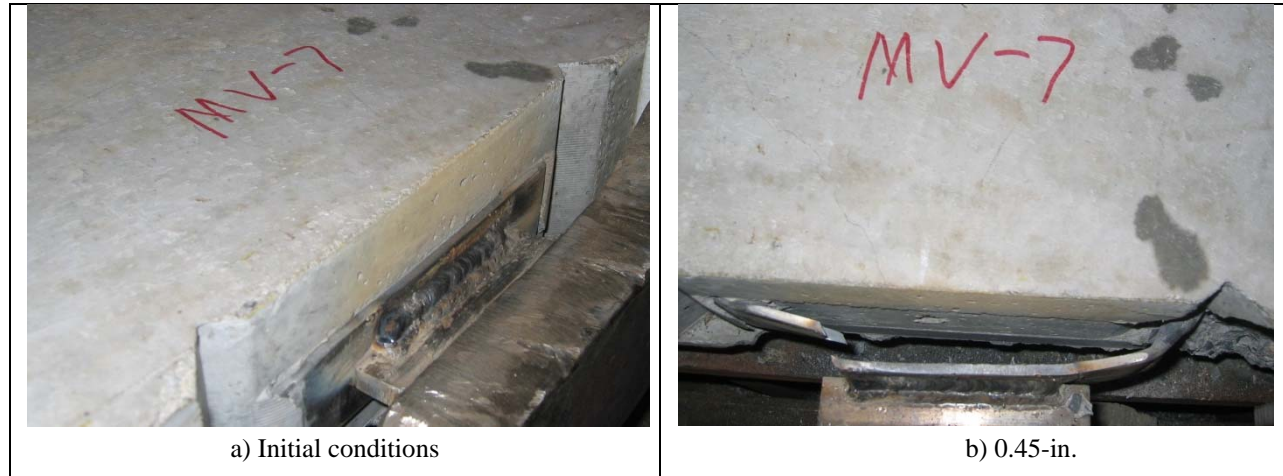
Figure 84: Damage state at various In-plane shear deformations D4

The performance of the Universal connection subject to monotonic in-plane shear is presented in this section. The panel was subjected to shear displacement with the tension force unrestrained. Connector damage progression consisted of faceplate bending followed by faceplate fracture at the tip of weld between slug and faceplate. The ultimate loss in capacity occurred due to abrupt faceplate failure. The observed key events and the corresponding displacement level are presented in Table 46. The photos of the damage states are presented in Figure 84. The final condition of the specimen is presented in Figure 85. The global force deformation response and backbone curve are presented in Table 47 and Figure 86.

Event #	Shear Δ Step [in.]	Event Description
1	0.45	Faceplate bent and fractured abruptly

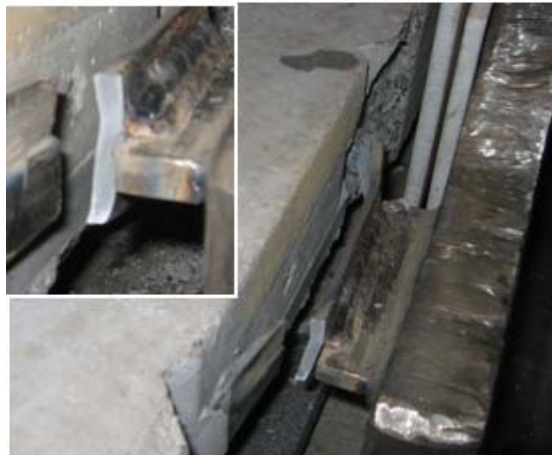
Figure 85: Final condition of test D4

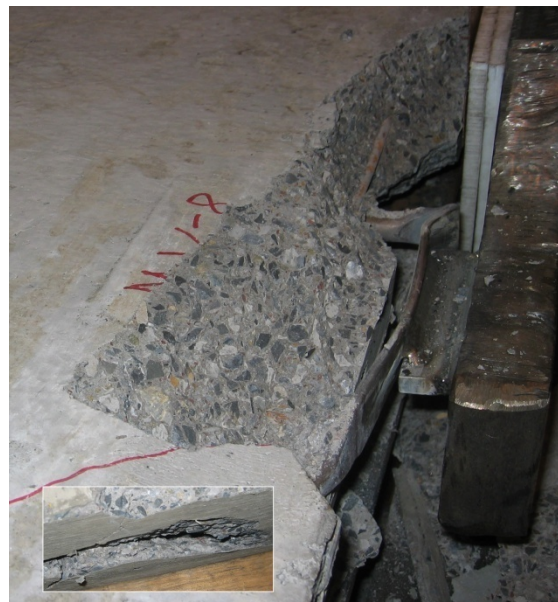
Figure 88: Final condition of test E4

The performance of the Universal connection subject to monotonic in-plane shear is presented in this section. The panel was subjected to shear displacement with the tension force unrestrained. Connector damage progression consisted of faceplate bending followed by bearing on the tension anchorage leg and concrete cracks and spalling around the connector legs. The test was conducted until the load cell was out of stroke. The observed key events and the corresponding displacement level are presented in Table 48. The photos of the damage states are presented in Figure 87. The final condition of the specimen is presented in Figure 88. The global force deformation response and backbone curve are presented in Table 49 and Figure 89.

Table 48: Key Test Observations (In-plane shear) E4		
Event #	Shear Δ Step [in.]	Event Description
1	0.73	Faceplate bending; Crack formed above the tension leg on the panel; Concrete spalling around the compression leg
2	1.38	Bending of connector legs and faceplate; Concrete continually spalled above the connector
3	2.00	Concrete continually spalled
6	2.14	End of test

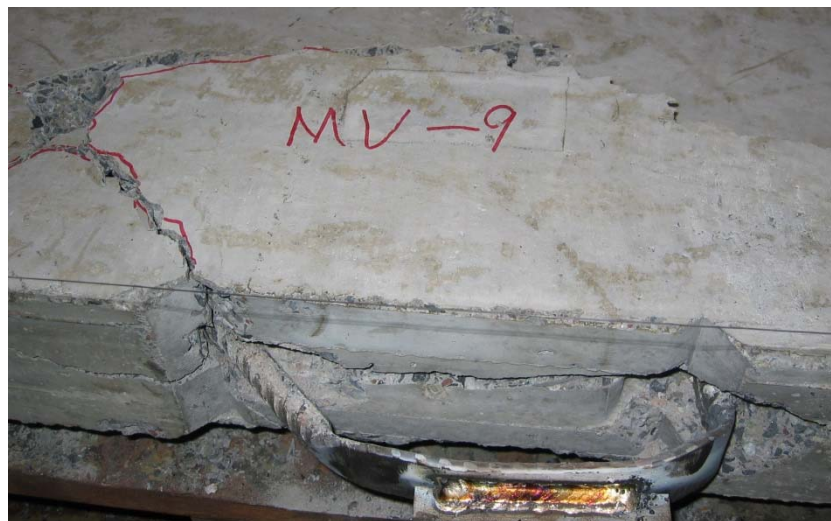
Figure 91: Final condition of test F2

The performance of the Universal connection subject to monotonic in-plane shear is presented in this section. The panel was subjected to shear displacement with the tension force unrestrained. Connector damage progression consisted of faceplate bending followed by bearing on the tension anchorage leg and concrete spalling around the connector legs. The ultimate loss in capacity occurred due to separation of the left anchorage leg from the surrounding concrete. The observed key events and the corresponding displacement level are presented in Table 50. The photos of the damage states are presented in Figure 90. The final condition of the specimen is presented in Figure 91. The global force deformation response and backbone curve are presented in Table 51 and Figure 92.

Table 50: Key Test Observations (In-plane shear) F2		
Event #	Shear Δ Step [in.]	Event Description
1	0.26	Faceplate bending; Crack formed above the tension leg on the panel
2	0.32	Small crack formed around tension leg on the joint face
3	0.40	Bending of connector legs and faceplate; Concrete spalling above the tension leg of connector; Existing cracks progressed
4	1.29	Concrete continually spalled; Tension leg was pull out of the panel
6	2.19	End of test

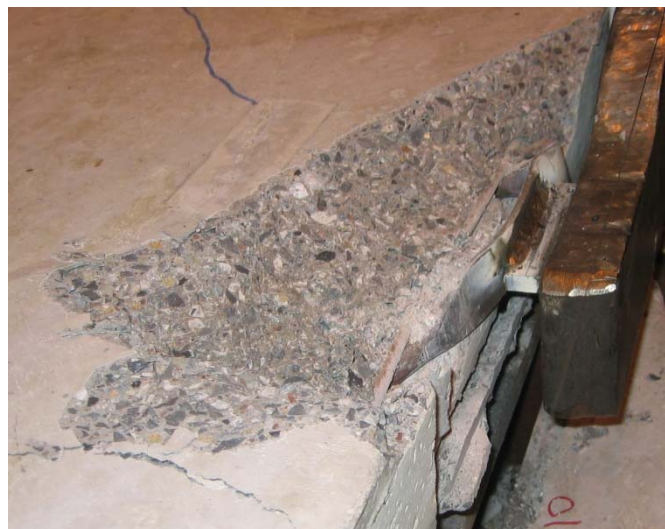
Figure 94: Final condition of test E5

The performance of the Universal connection subject to monotonic in-plane shear is presented in this section. The panel was subjected to shear displacement with the tension force unrestrained. Connector damage progression consisted of faceplate bending followed by bearing on the tension anchorage leg and concrete spalling around the connector legs. The test was conducted until the load cell was out of stroke. The observed key events and the corresponding displacement level are presented in Table 52. The photos of the damage states are presented in Figure 93. The final condition of the specimen is presented in Figure 94. The global force deformation response and backbone curve are presented in Table 53 and Figure 95.

Table 52: Key Test Observations (In-plane shear) E5		
Event #	Shear Δ Step [in.]	Event Description
1	0.12	Faceplate bending
2	0.59	Small spalling formed around compression leg on the joint face
3	1.27	Bending of connector legs and faceplate; Concrete spalling above the connector legs
4	2.10	Concrete continually spalled
6	2.23	End of test

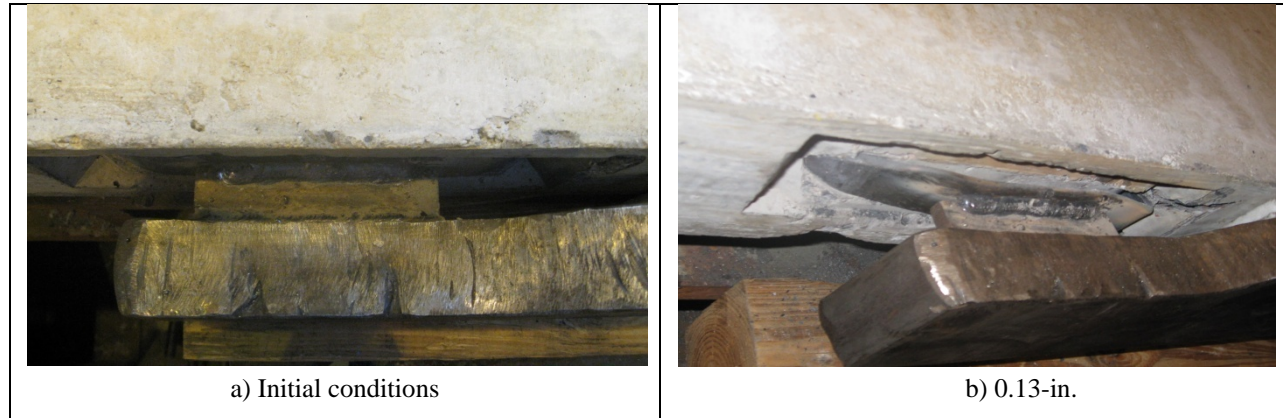
Figure 96: Damage state at various In-plane shear deformations H1

The performance of the Universal ASTM A36 connection subject to monotonic in-plane shear is presented in this section. The panel was subjected to shear displacement with the tension force unrestrained. Connector damage progression consisted of faceplate bending followed by faceplate fracture near where they become embedded in the concrete. The ultimate loss in capacity occurred due to abrupt faceplate failure. The observed key events and the corresponding displacement level are presented in Table 54. The photos of the damage states are presented in Figure 96. The final condition of the specimen is presented in Figure 97. The global force deformation response and backbone curve are presented in Table 55 and Figure 98.

Table 54: Key Test Observations (In-plane shear) H1		
Event #	Shear Δ Step [in.]	Event Description
1	0.13	Plate bending
2	0.65	Faceplate fractured abruptly

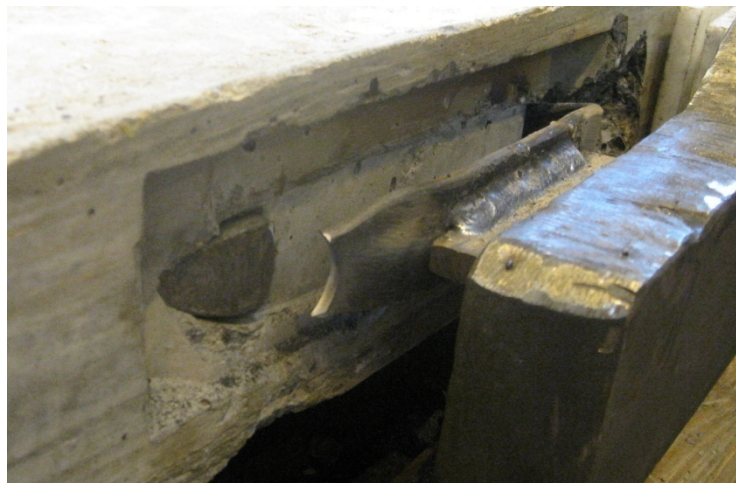
Figure 97: Final condition of test H1

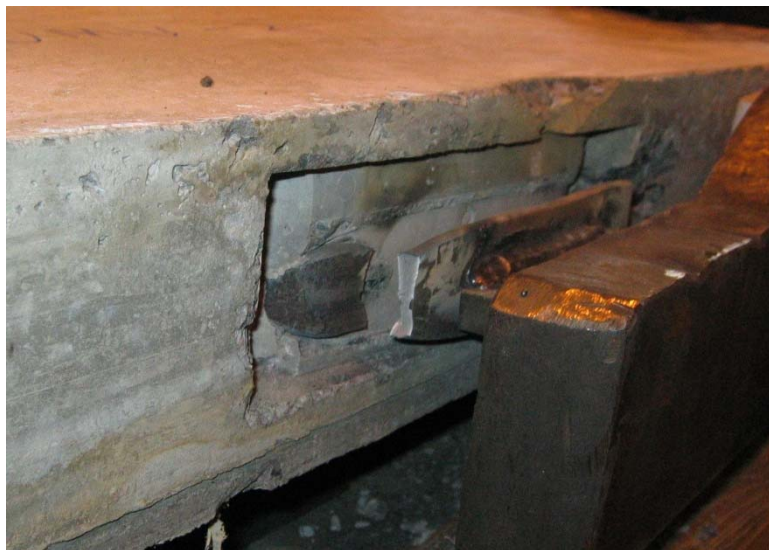
Figure 100: Final condition of test H2

The performance of the Universal ASTM A36 connection subject to monotonic in-plane shear is presented in this section. The panel was subjected to shear displacement with the tension force unrestrained. Connector damage progression consisted of faceplate bending followed by faceplate fracture near where they become embedded in the concrete. The ultimate loss in capacity occurred due to abrupt faceplate failure. The observed key events and the corresponding displacement level are presented in Table 56. The photos of the damage states are presented in Figure 99. The final condition of the specimen is presented in Figure 100. The global force deformation response and backbone curve are presented in Table 57 and Figure 101.

Table 56: Key Test Observations (In-plane shear) H2		
Event #	Shear Δ Step [in.]	Event Description
1	0.14	Plate bending
2	0.63	Faceplate fractured abruptly

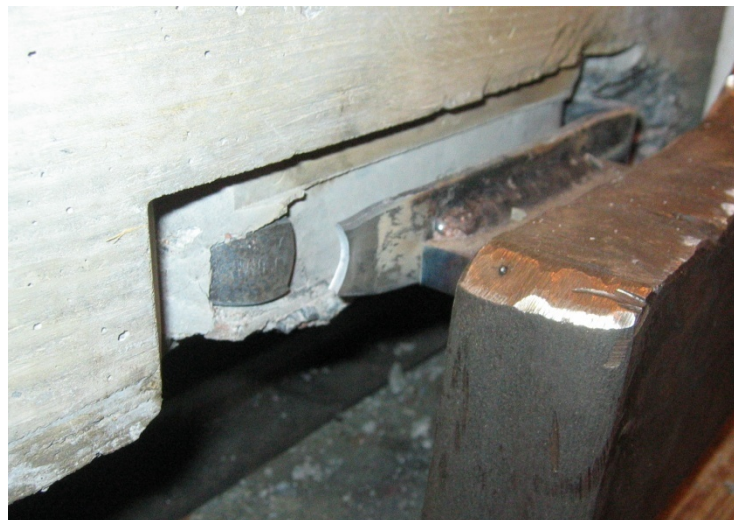
Figure 103: Final condition of test G1

The performance of the Universal ASTM A36 connection subject to monotonic in-plane shear is presented in this section. The panel was subjected to shear displacement with the tension force unrestrained. Connector damage progression consisted of faceplate bending followed by faceplate fracture near where they become embedded in the concrete. The ultimate loss in capacity occurred due to abrupt faceplate failure. The observed key events and the corresponding displacement level are presented in Table 58. The photos of the damage states are presented in Figure 102. The final condition of the specimen is presented in Figure 103. The global force deformation response and backbone curve are presented in Table 59 and Figure 104.

Event #	Shear Δ Step [in.]	Event Description
1	0.16	Plate bending
2	0.57	Faceplate fractured abruptly

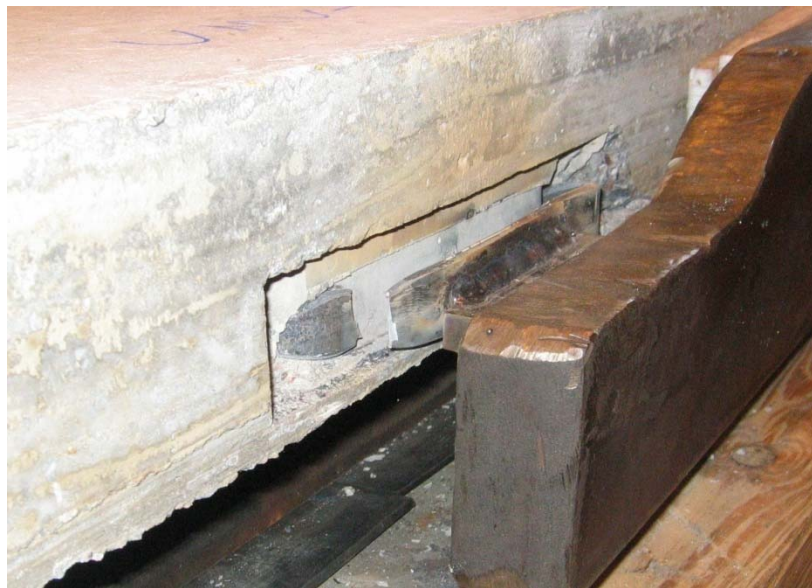
Figure 106: Final condition of test G2

The performance of the Universal ASTM A36 connection subject to monotonic in-plane shear is presented in this section. The panel was subjected to shear displacement with the tension force unrestrained. Connector damage progression consisted of faceplate bending followed by faceplate fracture near where they become embedded in the concrete. The ultimate loss in capacity occurred due to abrupt faceplate failure. The observed key events and the corresponding displacement level are presented in Table 60. The photos of the damage states are presented in Figure 105. The final condition of the specimen is presented in Figure 106. The global force deformation response and backbone curve are presented in Table 61 and Figure 107.

Event #	Shear Δ Step [in.]	Event Description
1	0.16	Plate bending
2	0.50	Faceplate fractured abruptly

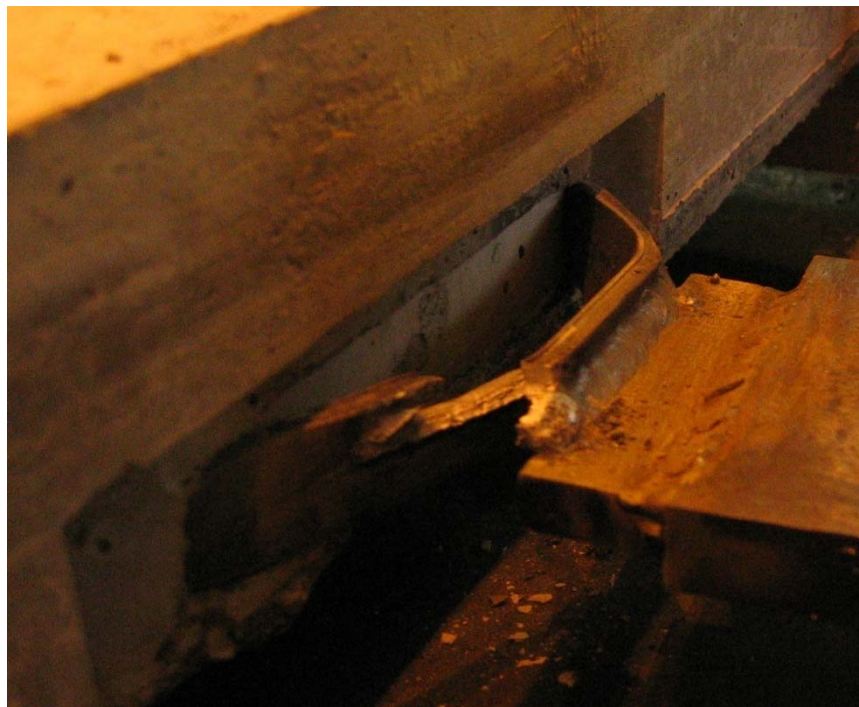
Figure 109: Final condition of test G3

The performance of the Universal ASTM A36 connection subject to monotonic, in-plane tension is presented in this section. The connector was subjected to in plane tension displacement with the shear force unrestrained. Connector response was characterized by bending of the faceplate with application of tension. No damage was observed on the concrete surrounding the connection. Loss in capacity occurred due to failure of the faceplate. The observed key events and the corresponding displacement level are presented in Table 62. The photos of the damage states are presented in Figure 108. The final condition of the specimen is presented in Figure 109. The global force deformation response and backbone curve are presented in Table 63 and Figure 110.

Table 62: Key Test Observations (In-plane tension) G3		
Event #	Tension Δ Step [in.]	Event Description
1	0.62	Plate bending
2	1.17	Faceplate fractured

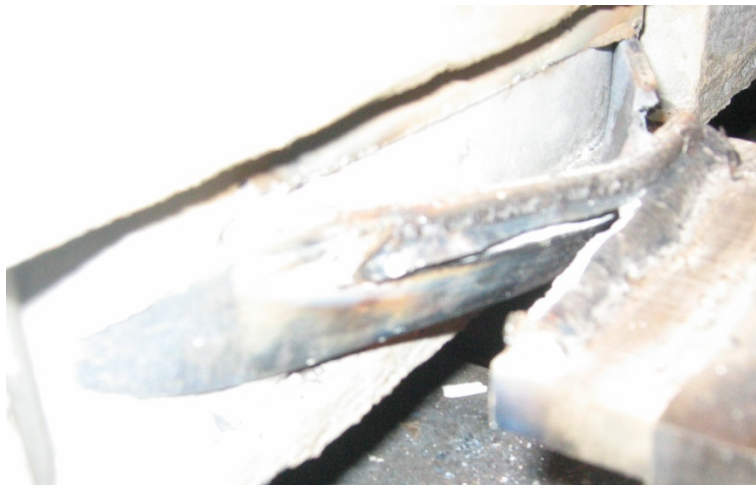
Figure 112: Final condition of test G4

The performance of the Universal ASTM A36 connection subject to monotonic, in-plane tension is presented in this section. The connector was subjected to in plane tension displacement with the shear force unrestrained. Connector response was characterized by bending of the faceplate with application of tension. No damage was observed on the concrete surrounding the connection. Loss in capacity occurred due to failure of the faceplate. The observed key events and the corresponding displacement level are presented in Table 64. The photos of the damage states are presented in Figure 111. The final condition of the specimen is presented in Figure 112. The global force deformation response and backbone curve are presented in Table 65 and Figure 113.

Table 64: Key Test Observations (In-plane tension) G4		
Event #	Tension Δ Step [in.]	Event Description
1	0.26	Plate bent
2	0.63	Plate bent and weld tear at both tips
3	1.30	Faceplate completely fractured

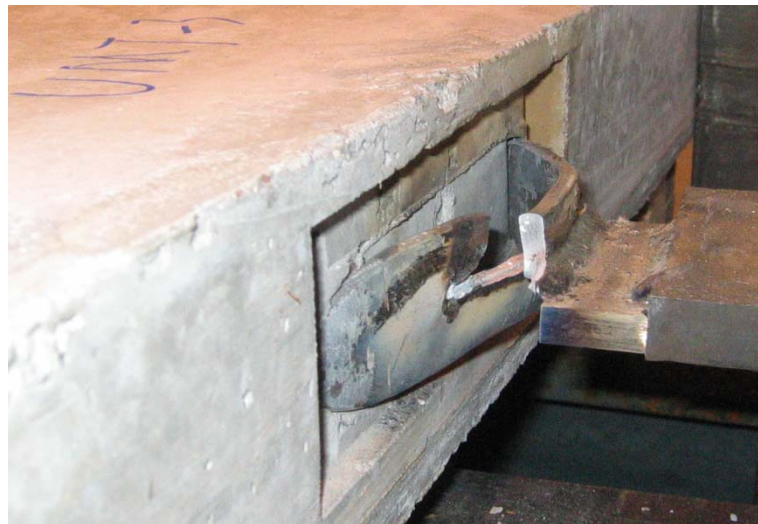
Figure 115: Final condition of test H3

The performance of the Universal ASTM A36 connection subject to monotonic, in-plane tension is presented in this section. The connector was subjected to in plane tension displacement with the shear force unrestrained. Connector response was characterized by bending of the faceplate with application of tension. No damage was observed on the concrete surrounding the connection. Loss in capacity occurred due to failure of the faceplate. The observed key events and the corresponding displacement level are presented in Table 66. The photos of the damage states are presented in Figure 114. The final condition of the specimen is presented in Figure 115. The global force deformation response and backbone curve are presented in Table 67 and Figure 116.

Event #	Tension Δ Step [in.]	Event Description
1	0.26	Plate bent and weld tear at the tip
2	0.60	Faceplate fractured
3	0.93	Faceplate completely fractured

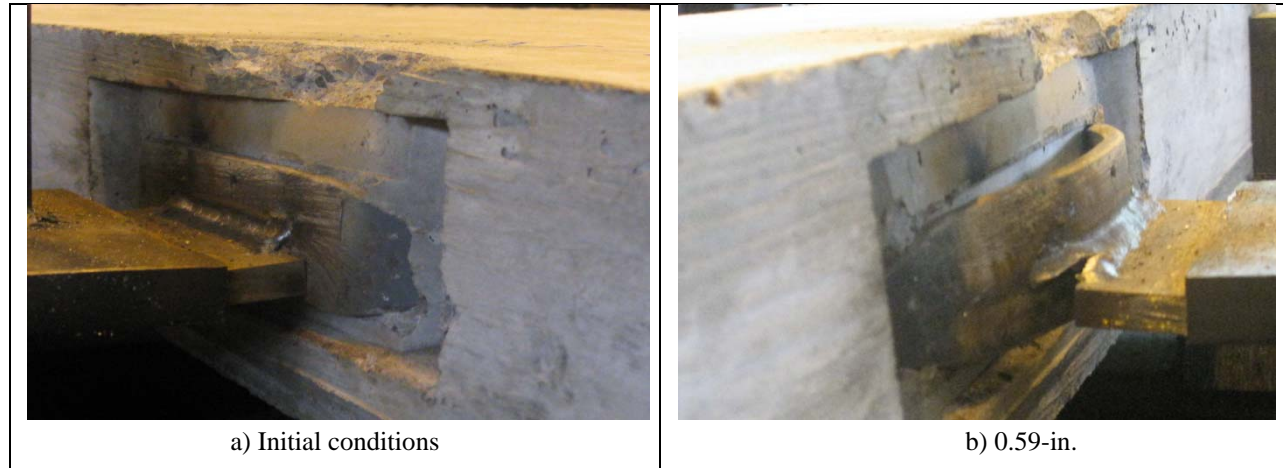
Figure 117: Damage state at various In-plane tension deformations H4

The performance of the Universal ASTM A36 connection subject to monotonic, in-plane tension is presented in this section. The connector was subjected to in plane tension displacement with the shear force unrestrained. Connector response was characterized by bending of the faceplate with application of tension. No damage was observed on the concrete surrounding the connection. Loss in capacity occurred due to failure of the faceplate. The observed key events and the corresponding displacement level are presented in Table 68. The photos of the damage states are presented in Figure 117. The final condition of the specimen is presented in Figure 118. The global force deformation response and backbone curve are presented in Table 69 and Figure 119.

Event #	Tension Δ Step [in.]	Event Description
1	0.59	Plate bent and weld tear at the tip
2	0.85	Faceplate completely fractured

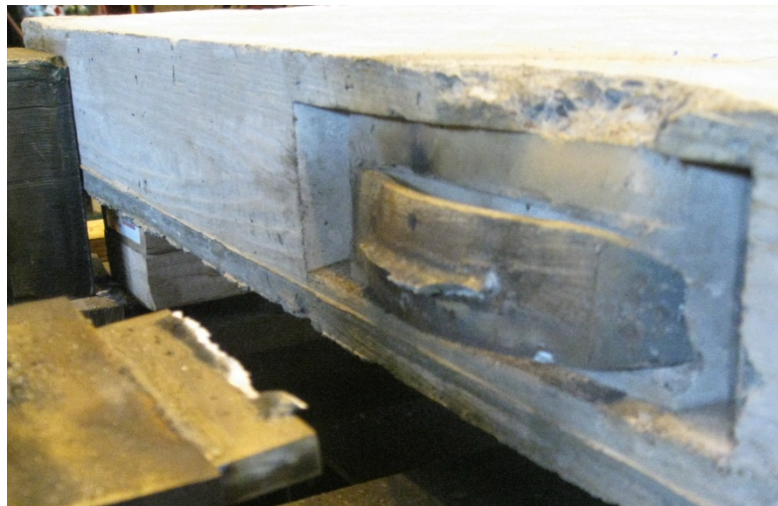
Figure 118: Final condition of test H4
